SPECIAL AIRWORTHINESS INFORMATION BULLETIN

SW-06-64
August 17, 2006

This Special Airworthiness Information Bulletin provides information concerning the Vertical Fin Spar Kit installation, part number VTF-030-800, -801, or -802, manufactured by Global Helicopter Technology, Inc. (GHTI) for owners and operators of the following helicopters models:

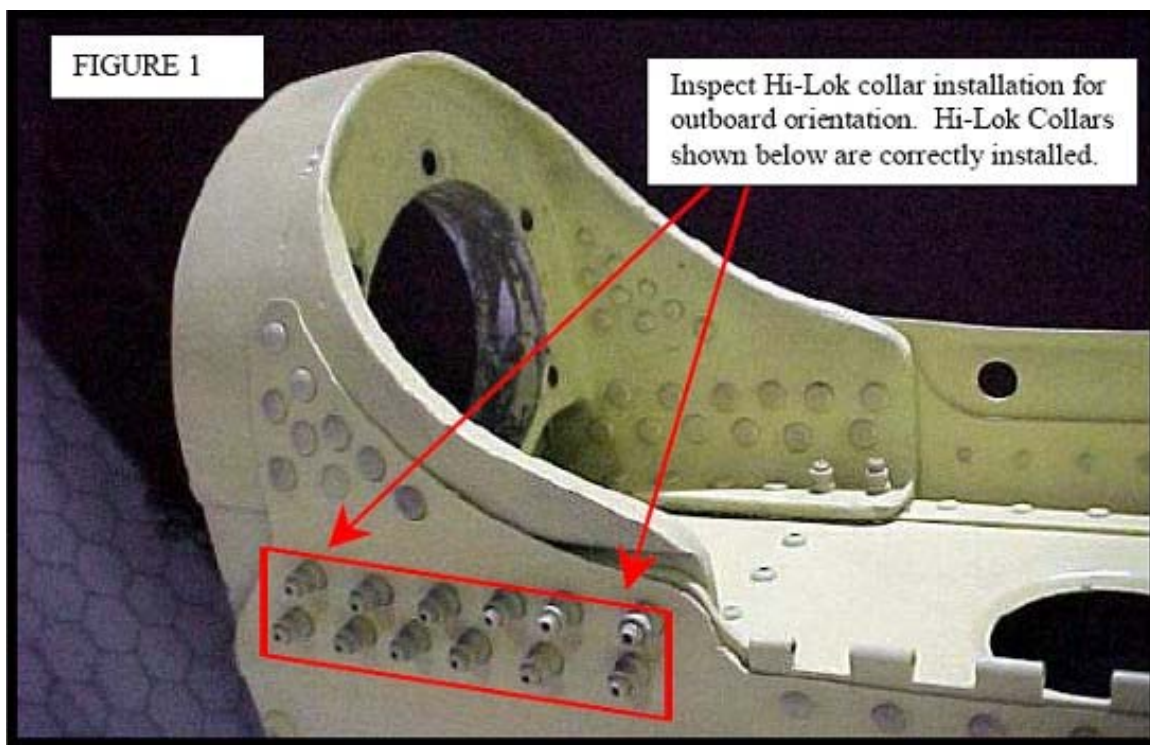
Figure 1

Correct Orientation of Hi-Loks with Collars Facing Outboard

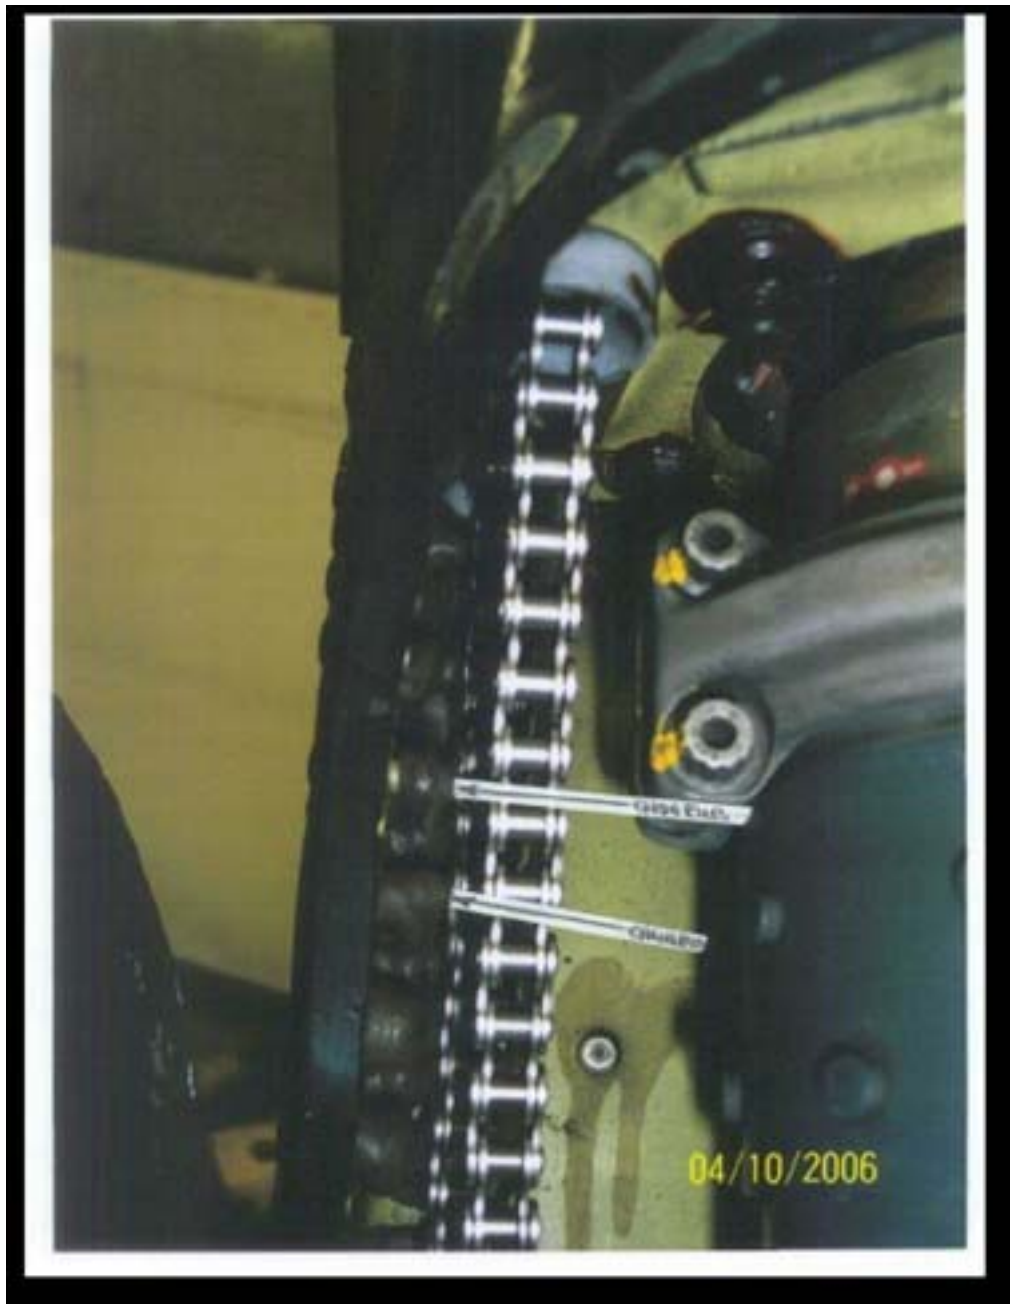
Figure 2

GHTI released Alert Service Bulletin UH-1-01-001 dated August 9, 2001 (ASB) that pertains to the correct installation of the fasteners attaching the tail rotor 90-degree gearbox casting at the top of the vertical fin. The ASB details an inspection to determine if these fasteners are installed correctly and repair instructions, if necessary. These fasteners can rub against the tail rotor pitch control chain if the collars are facing inboard causing premature wear of the chain.

It has been reported to us that several helicopters have been found with these fasteners installed incorrectly.

Incorrect Installation of Hi-Loks Which Show
Rubbing on Tail Rotor Pitch Control Chain

- If a GHTI spar kit is installed and a record of compliance with the GHTI ASB cannot be confirmed, then inspect the Hi-Lok fasteners on the side of anti-torque control chain attaching the tail rotor 90-degree gearbox casting to the vertical fin spar in accordance with Steps 1 through 3 of the ASB. Insure the fasteners are installed with the collars facing outboard as shown in Figure 1 of this SAIB.
- If the fasteners are installed correctly, no further action is recommended.
- If the fasteners are installed with the collars facing inboard (See Figure 2) then carefully review Steps 4 though 8 in the

ASB. Perform the inspections and then repair, if necessary, per the instructions.
